INFORMATION BULLETIN

GOLDSEAL GROUP EPOXY CANCER

OBJECTIVE: To case study rectification of Epoxy cancers , by hand application of Cold Goldseal.

Fertilizer plant, Kwinana, Western Australia.

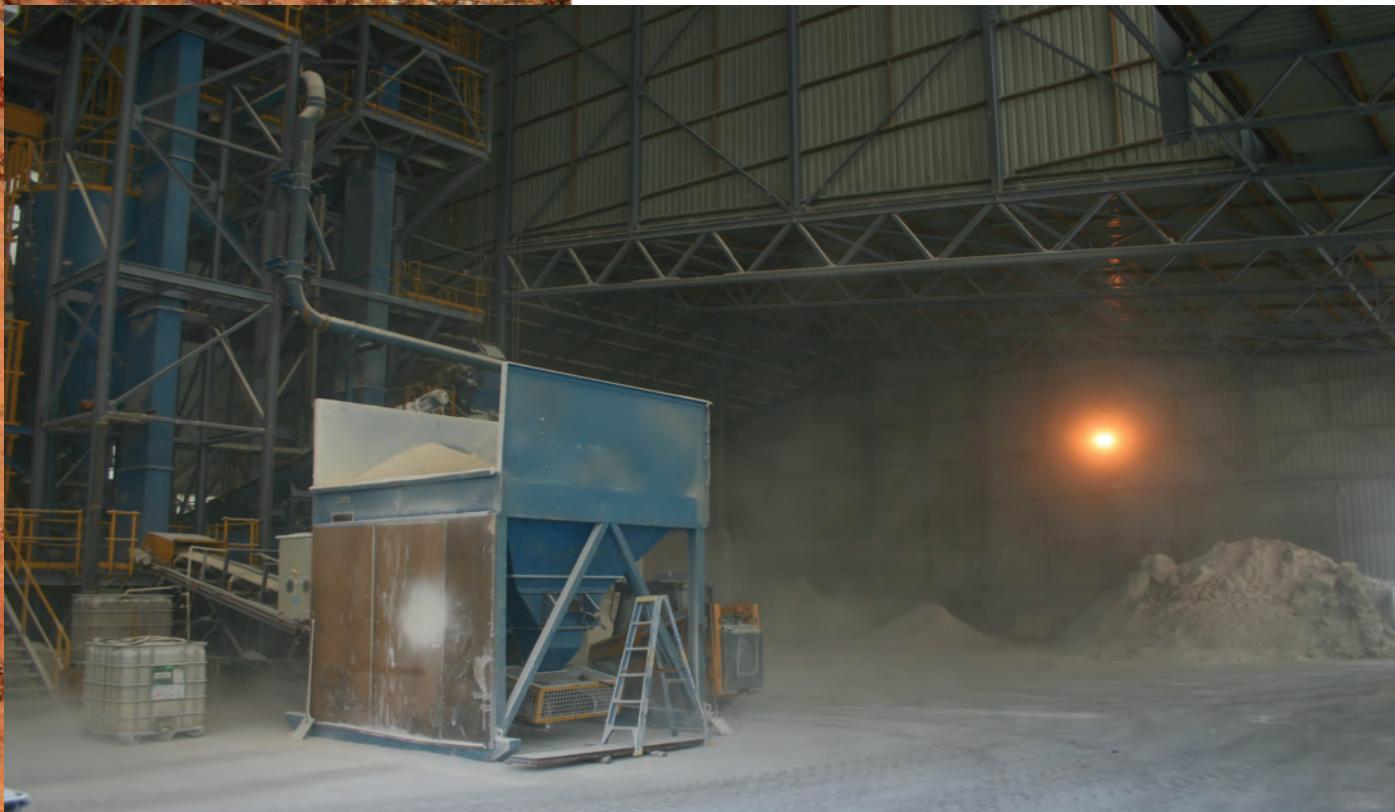
This 15 year old structure south of Perth was erected from I beam portals and hollow section diagonal bracing and hollow section roof trusses. These were all coated in factory applied Epoxy. While most of the coating is performing well there are thousands of epoxy cancers throughout this processing plant

Hollow section bracing and trusses cannot be allowed to perforate. The inside surface is not coated and unseen internal corrosion will collapse the truss.

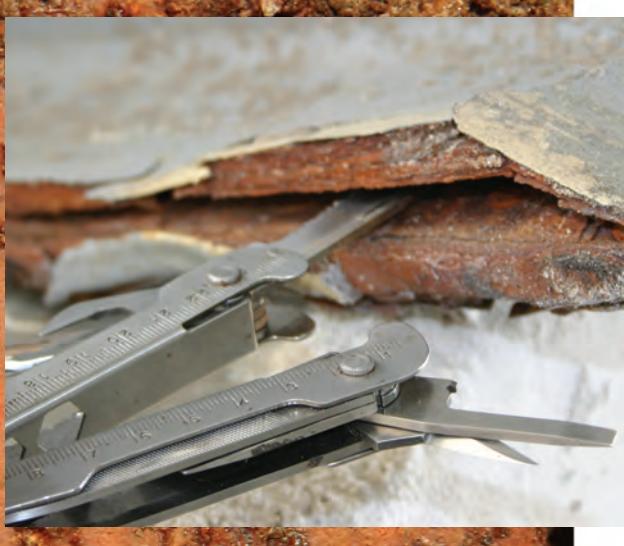
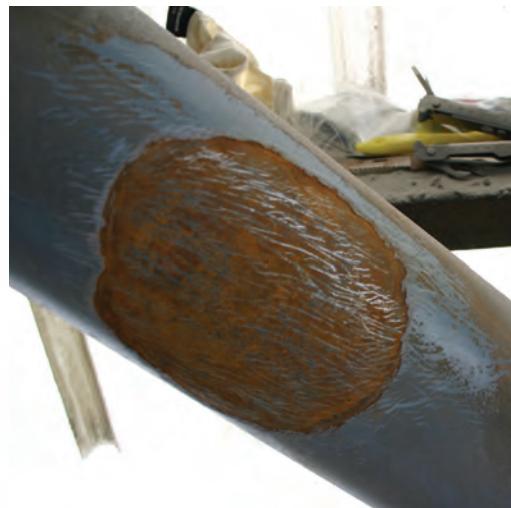
The cancers were opened by hand. Each cancer had undercut the coating by more than was visible

Each area was cut back until the coating adhered, then wire brushed, neutralized and dried using a rag or heat gun.
